MEMORANDUM

DATE: June 26, 2020
TO: Andrew Cannon
CC: Luis Diaz
FROM: JD Allen
RE: RGVMPPO 2045 MTP – Bridge and Roadway Condition Analysis

RGVMPO Transportation System Conditions and Performance

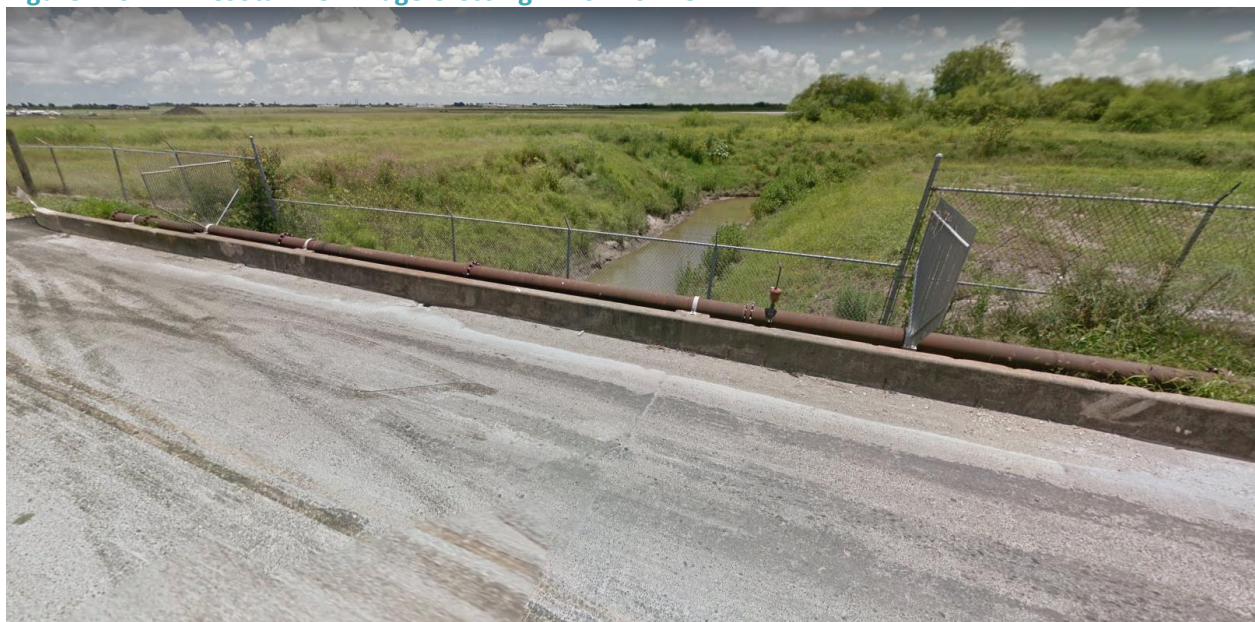
Figure 1: S. Minnesota Ave. Bridge Crossing - Brownsville

Figure 2 displays structurally deficient bridges at the RGVMAB level, showing poor bridge infrastructure to largely occur in rural, local areas of the roadway network. **Figure 3** through **Figure 6** display bridge conditions at more detailed extents for better context. Bridges have been numbered to match with table references detailing location, roadway, and bridge crossing type (**Table 2** through **Table 5**). The RGVMAB’s proximity to the Gulf Coast and Rio Grande River, along with a strong agricultural presence, produces many smaller bodies of water that are not immediately apparent. It must be noted that majority of the structurally deficient bridges within the RGVMAB are located on rural roads and are crossing small culverts and/or drainage lines (**Figure 1**).

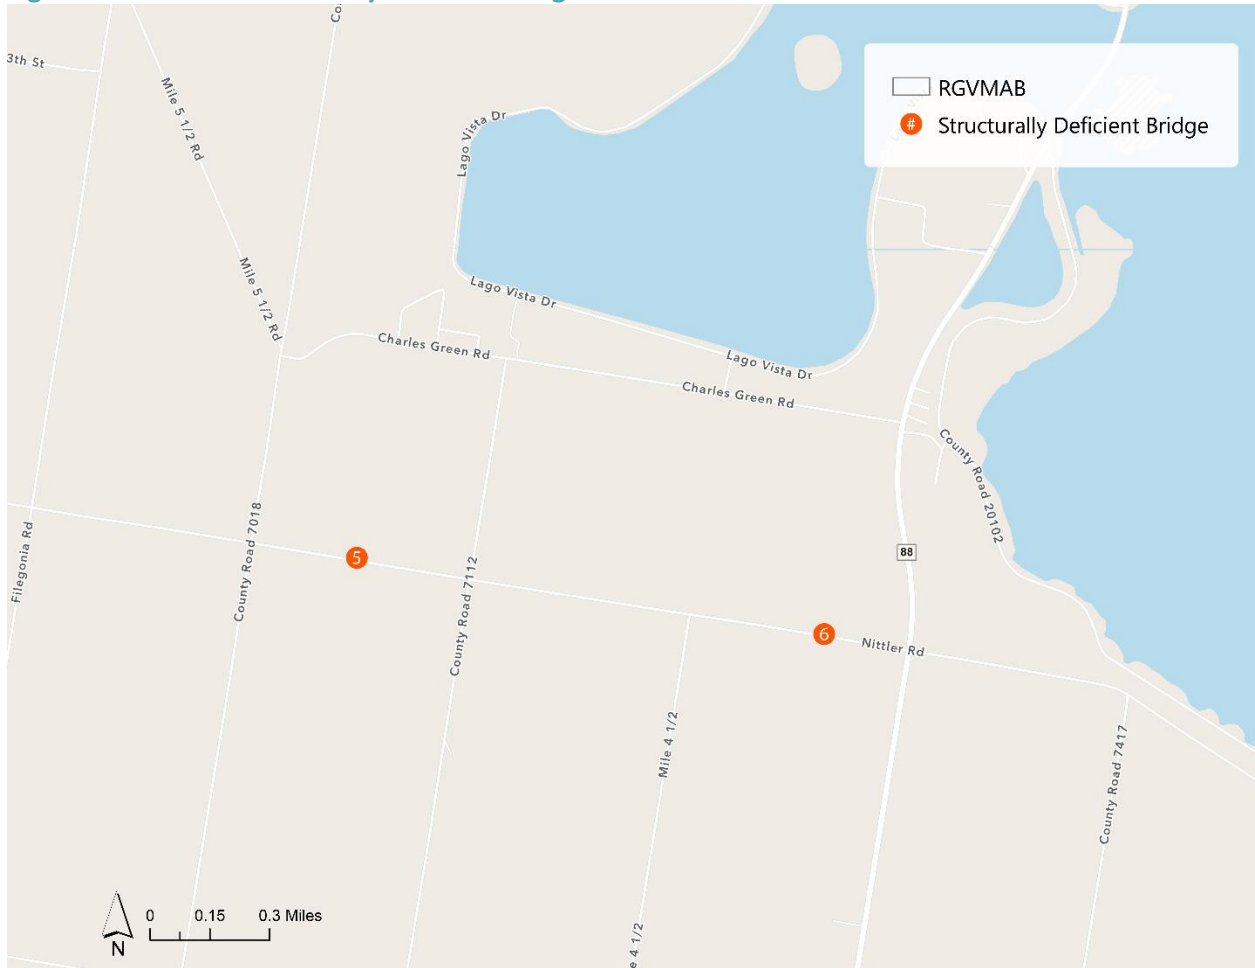
Figure 4: RGVMAB Structurally Deficient Bridges – Delta Lake Area

Bridge	Roadway	Facility Description
5	Nittler Rd.	Bridge crossing; culvert
6	Nittler Rd.	Bridge crossing; culvert

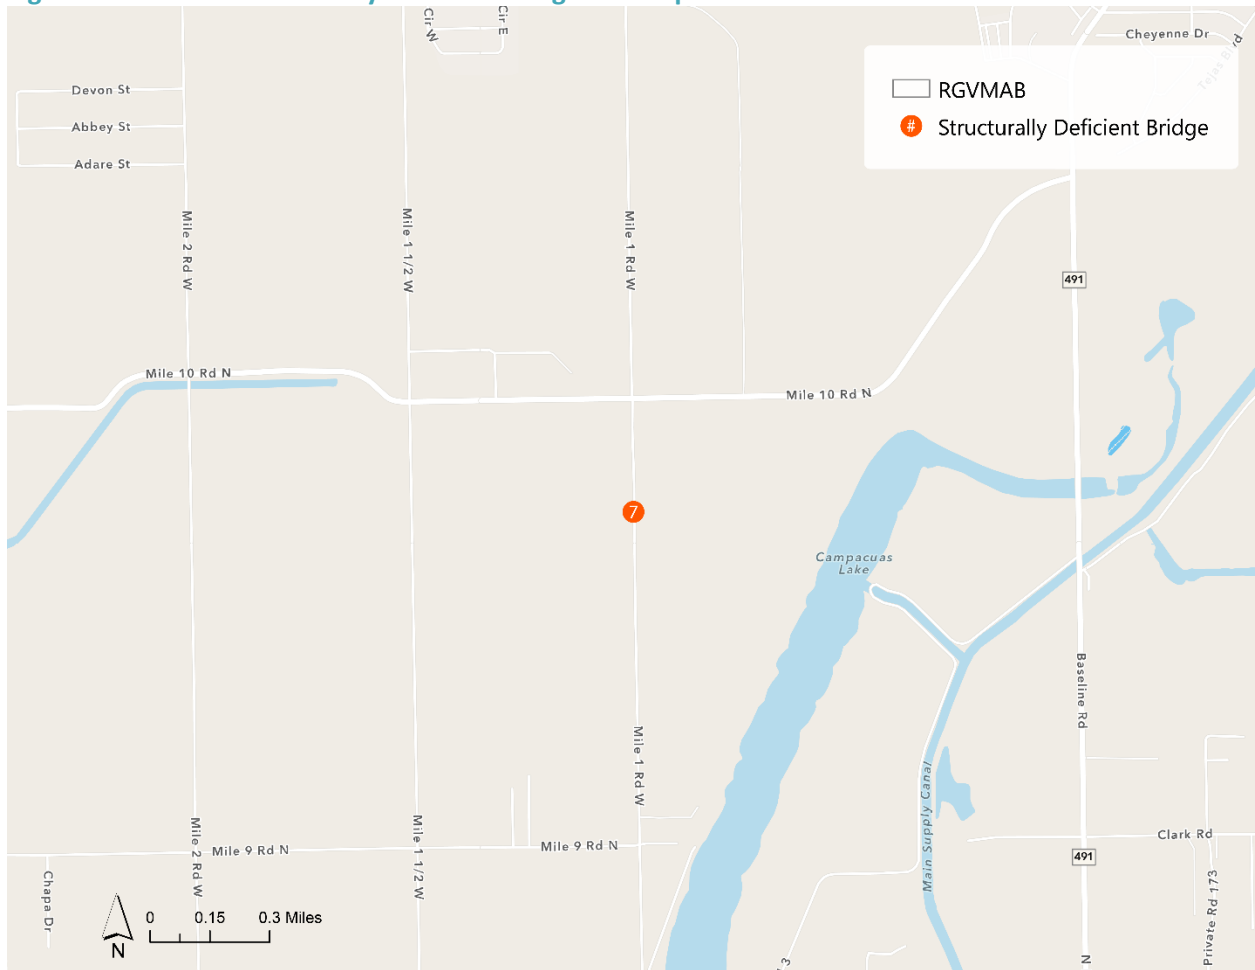
Figure 5: RGVMAB Structurally Deficient Bridges – Campacuas Lake Area

Bridge	Roadway	Facility Description
7	Mile 1 Rd. W.	Bridge crossing; channel

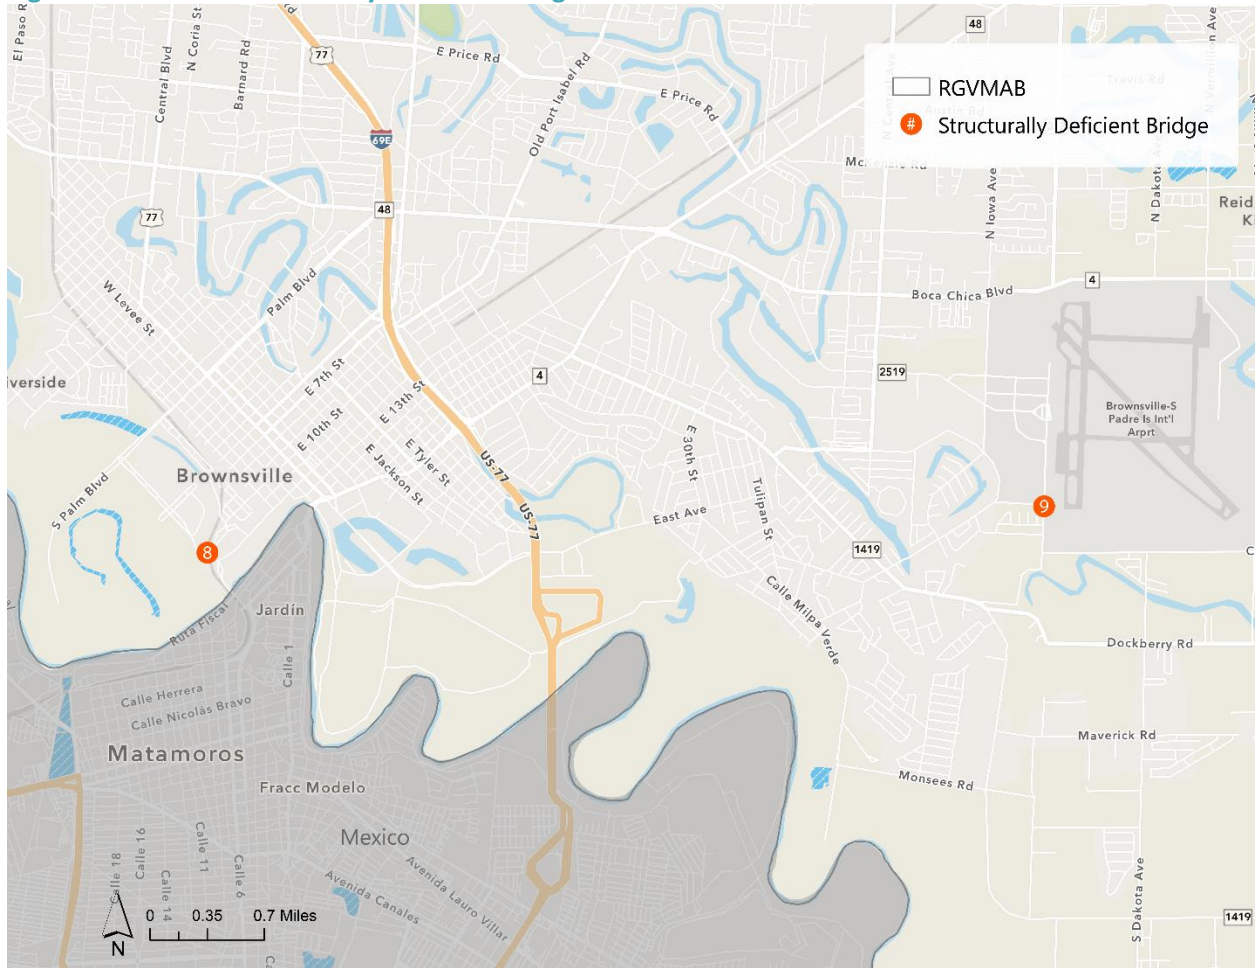
Figure 6: RGVMAB Structurally Deficient Bridges – Brownsville

Bridge	Roadway	Facility Description
8	Union Pacific Rail Crossing	Grade-separated railroad crossing; NB/SB over Mexico Blvd.
9	S. Minnesota Ave.	Bridge crossing; culvert

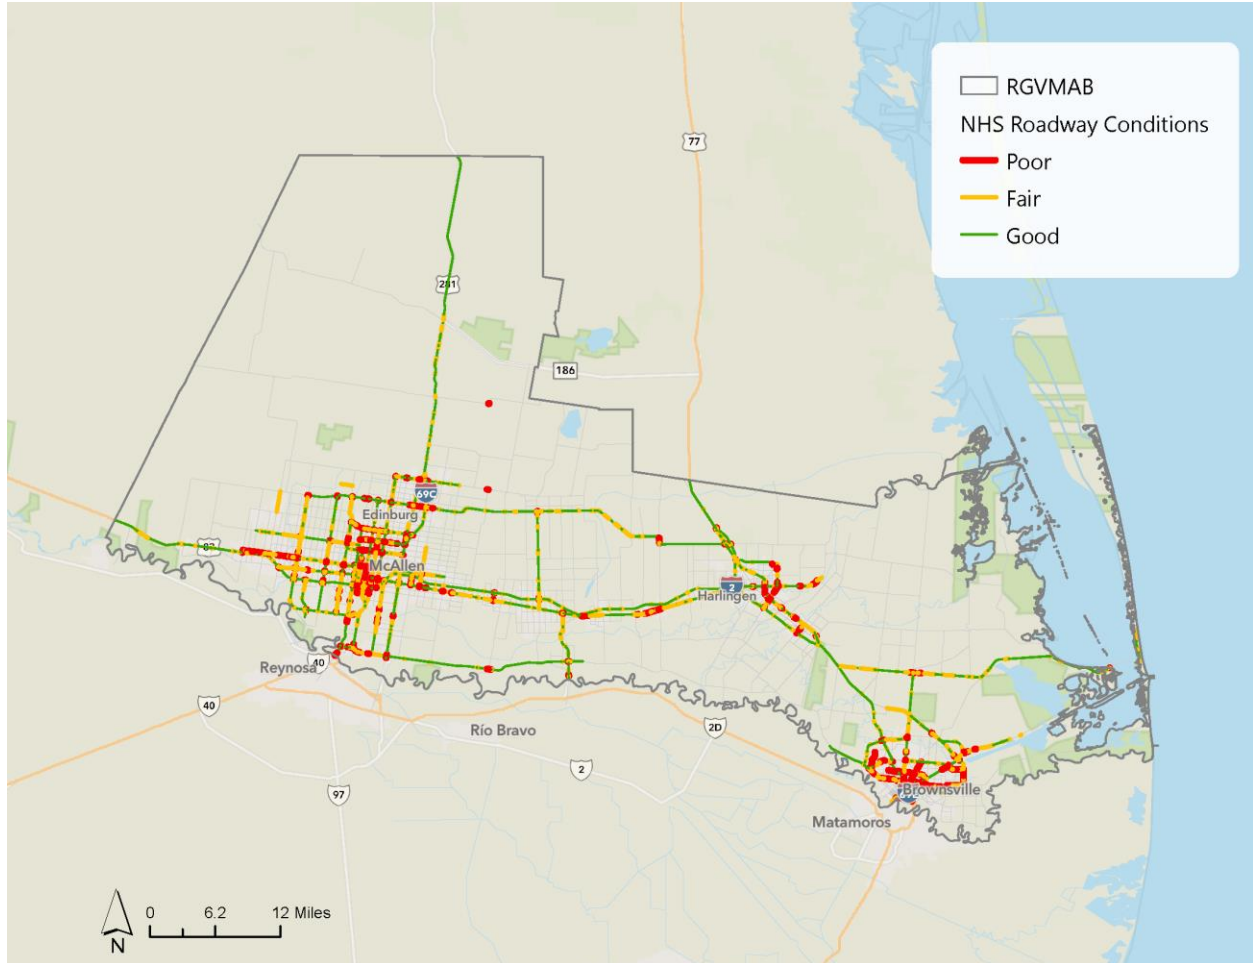
Figure 7: RGVMAB NHS Roadway Conditions

Figure 7 displays roadway pavement conditions for the NHS (both Interstate and Non-Interstate) at the RGVMAB level, showing majority of major interstate and highway infrastructure to be in a state of good repair.

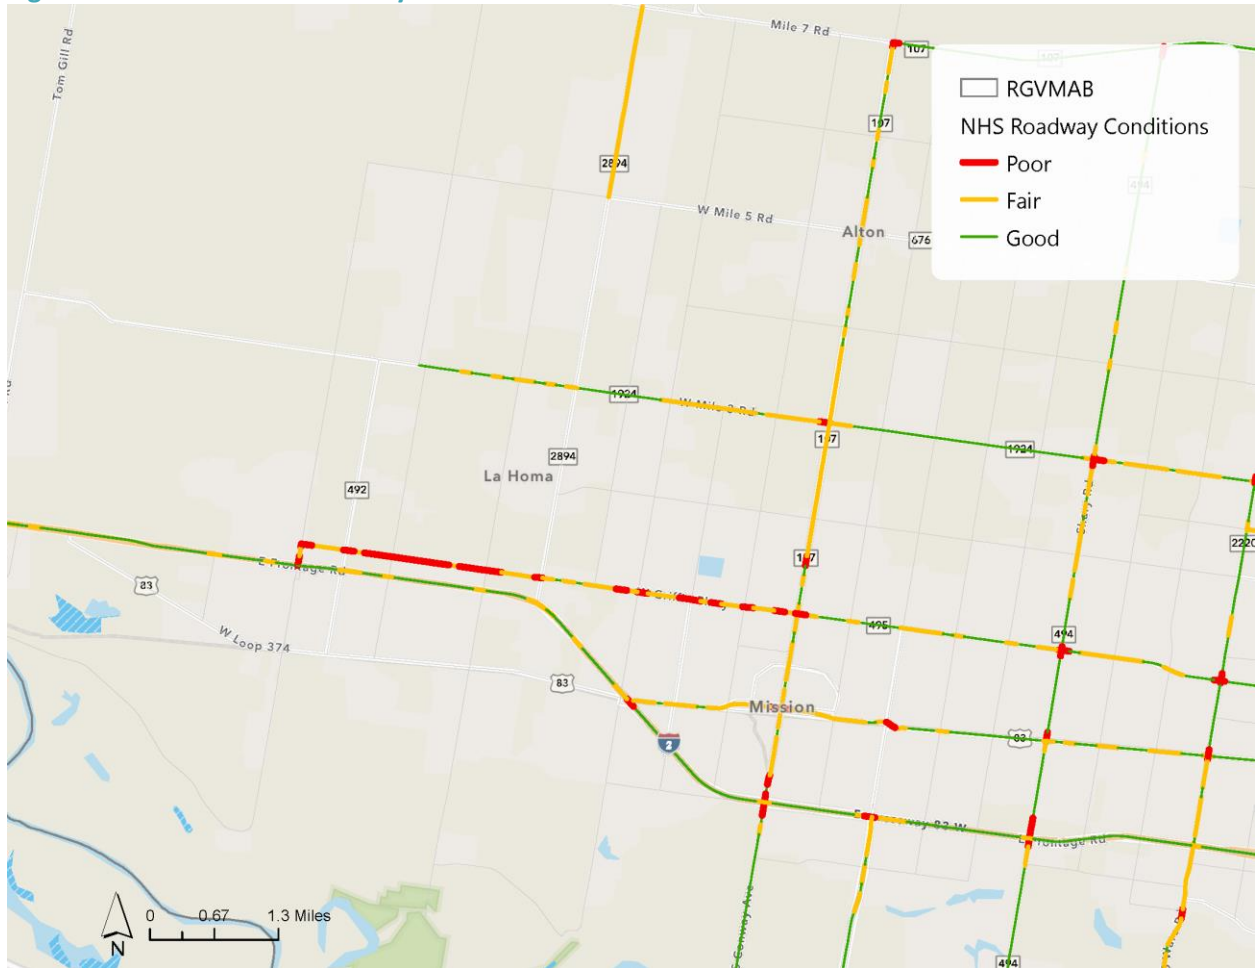
Figure 8: RGVMAB NHS Roadway Conditions – Mission Area

Figure 8 displays Mission area NHS roadway pavement conditions. One contiguous stretch of inadequate roadway pavement conditions exists along FM 495 parallel to I-2. Of note, several key intersections (e.g. FM 495 and FM 494) exist throughout the area containing poor roadway infrastructure.

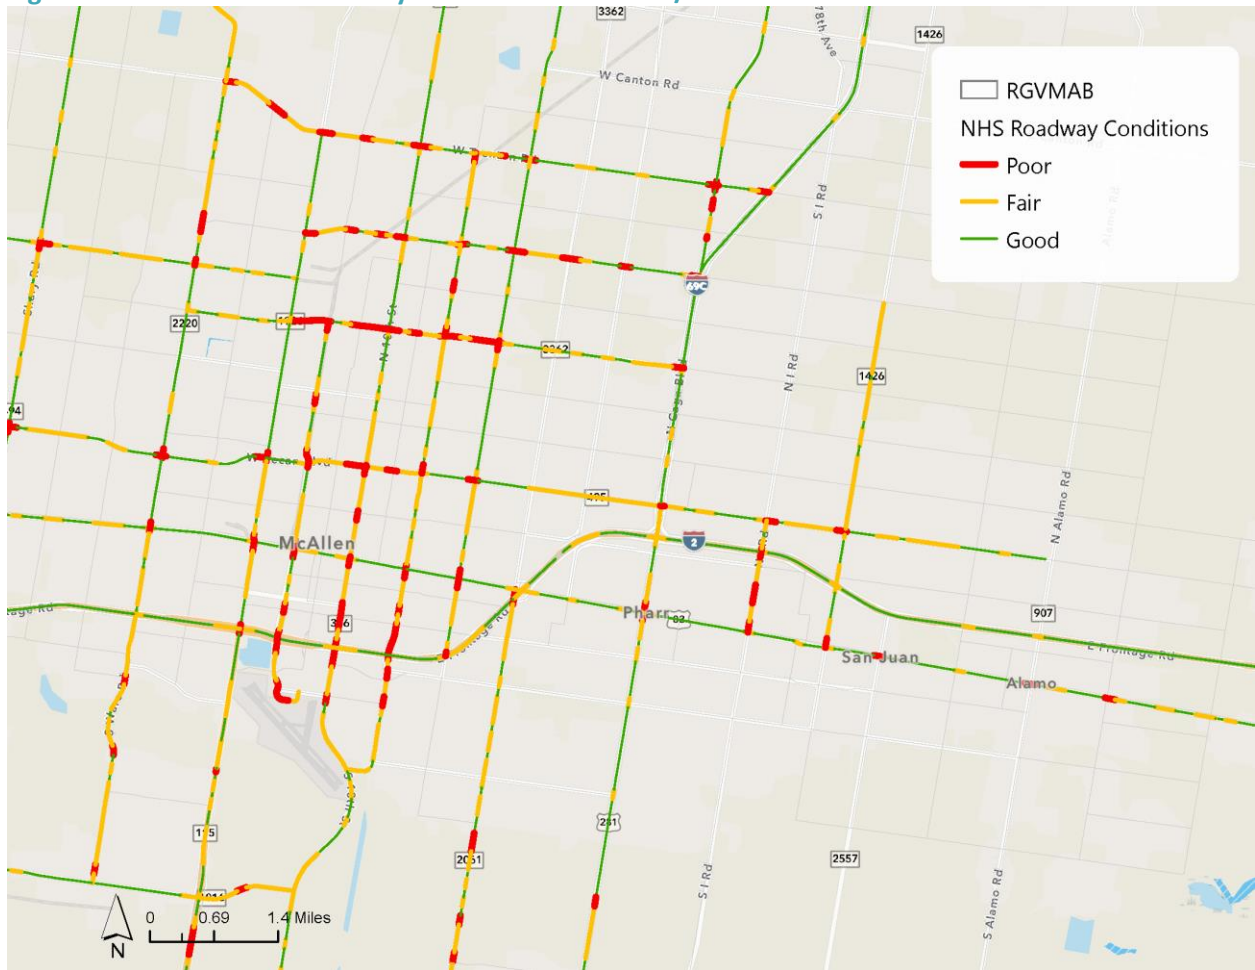
Figure 9: RGVMAB NHS Roadway Conditions – McAllen/Pharr Area

Figure 9 displays McAllen/Pharr area NHS roadway pavement conditions. Major arterials throughout the area contain intermittent roadway segments rated as having poor pavement conditions. This includes infrastructure such as W. Trenton Rd., Dove Ave., Nolana St., N. Bicentennial Blvd., S. 10th St., S. 2nd St., and N. I Rd.

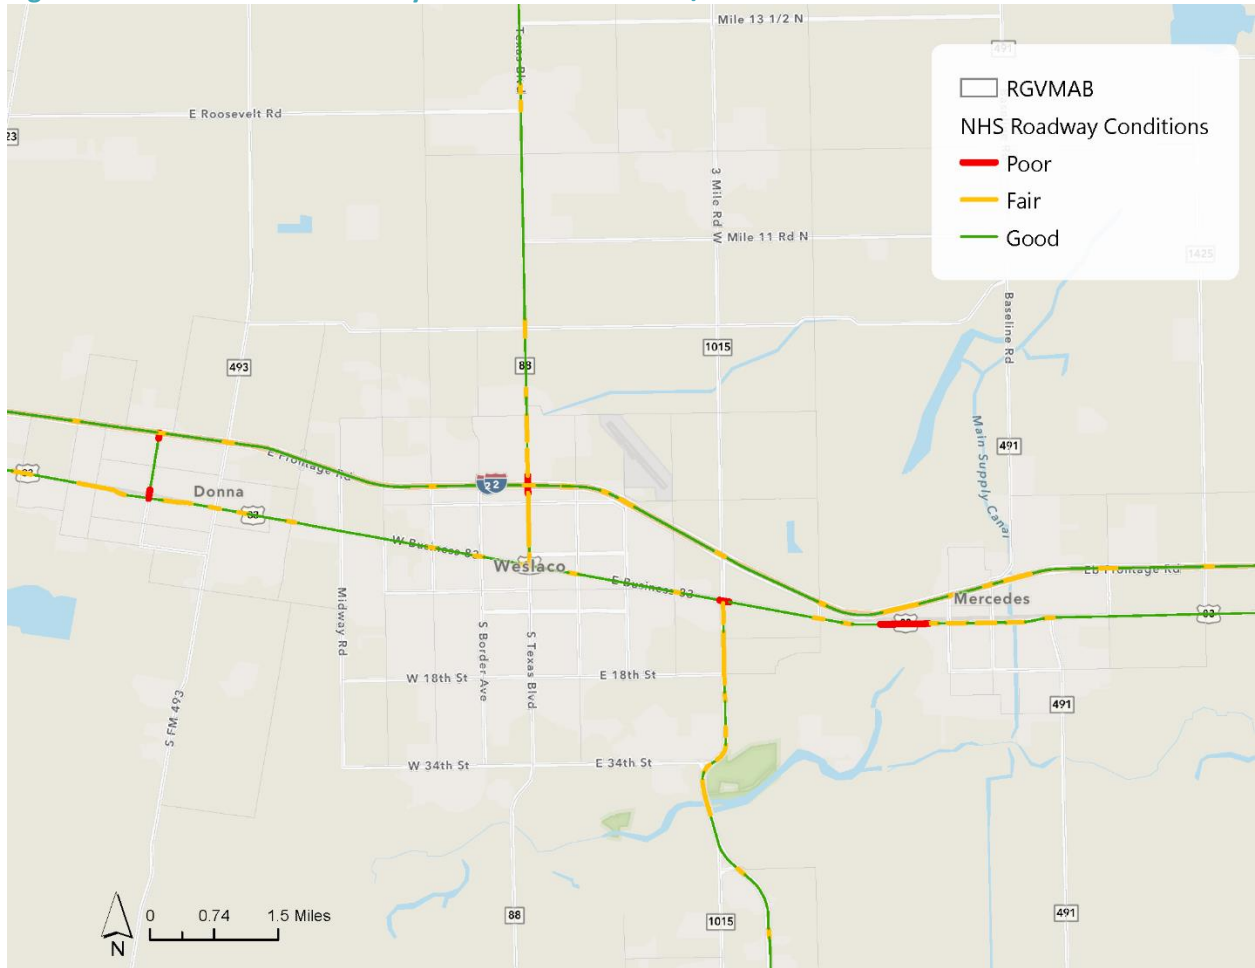
Figure 10: RGVMAB NHS Roadway Conditions – Weslaco/Mercedes Area

Figure 10 displays Weslaco/Mercedes area NHS roadway pavement conditions. While poor conditions in this area are limited, they do exist at critical intersections involving Business 83, US-83, and I-2.

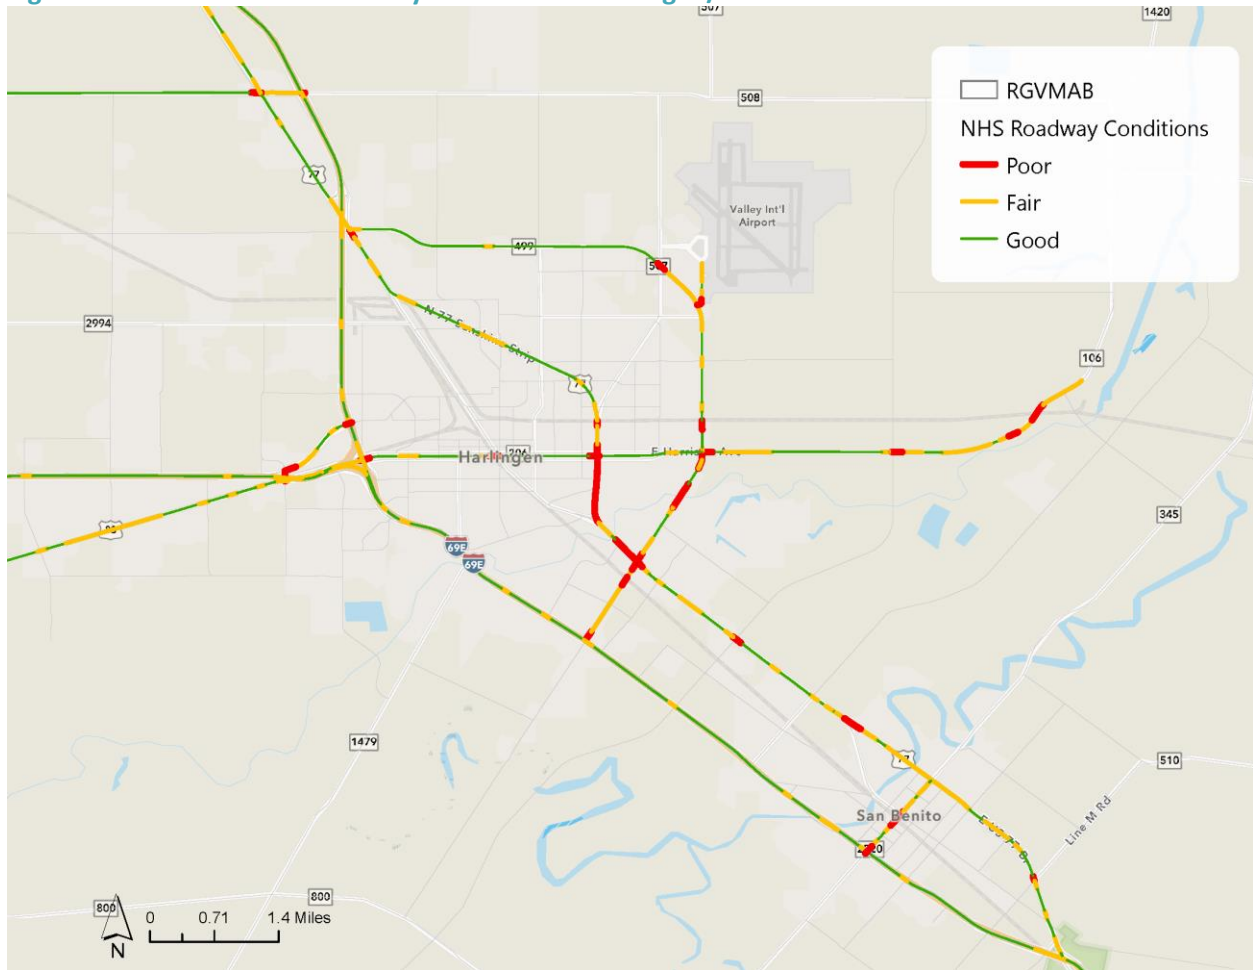
Figure 11: RGVMAB NHS Roadway Conditions – Harlingen/San Benito Area

Figure 11 displays Harlingen/San Benito area NHS roadway pavement conditions. The most noteworthy area containing inadequate roadway infrastructure includes US-77 and FM 499 in south Harlingen.

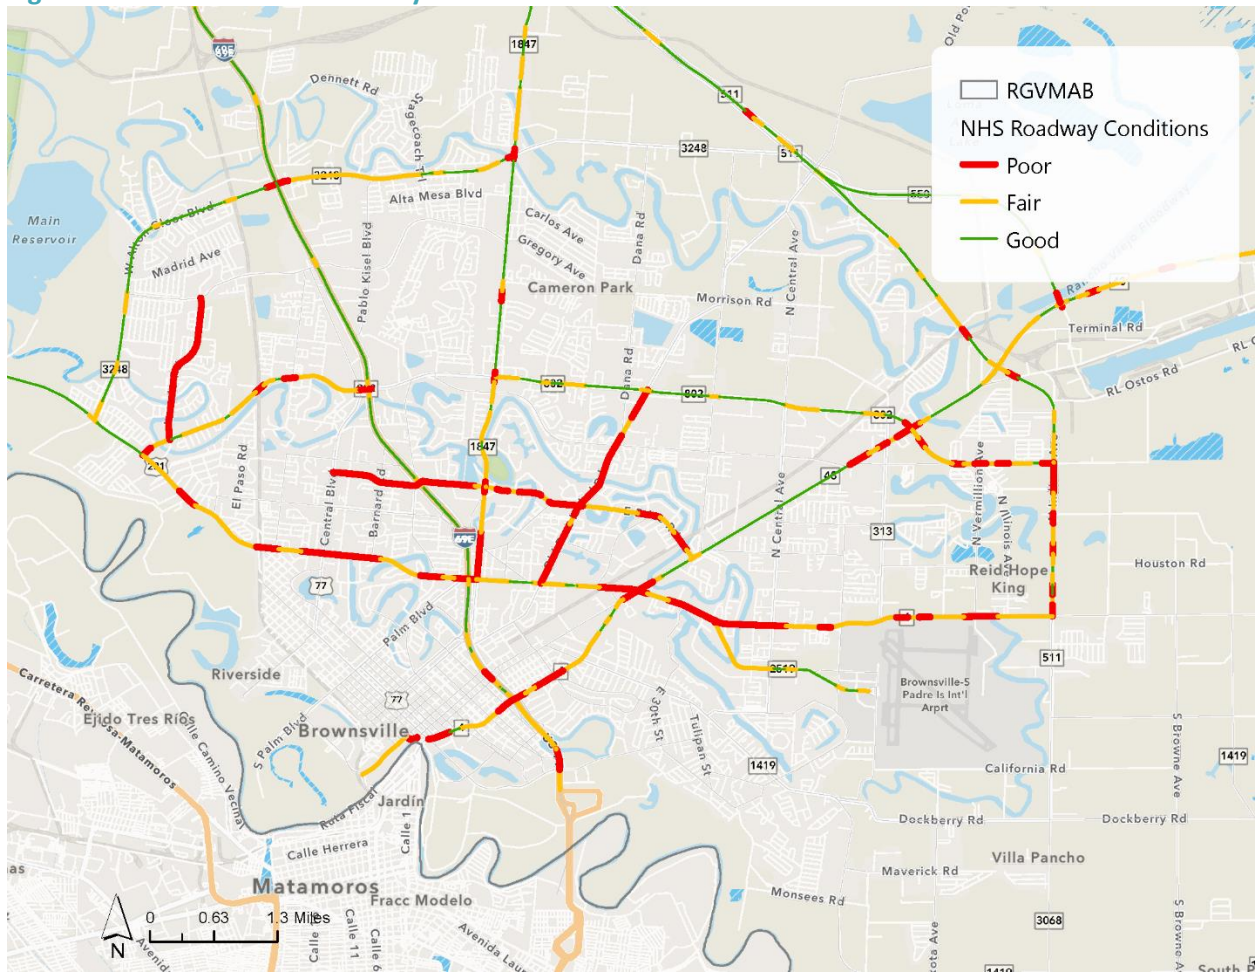
Figure 12: RGVMAB NHS Roadway Conditions – Brownsville Area

Figure 12 displays Brownsville area NHS roadway pavement conditions, which can be seen throughout the extent on major highway and arterial roadway infrastructure. Roadways of note include US-281, SH 48, SH 4, FM 511, Laredo Rd., E. Price Rd., Palm Blvd., E. 10th St., and Old Part Isabel Rd.

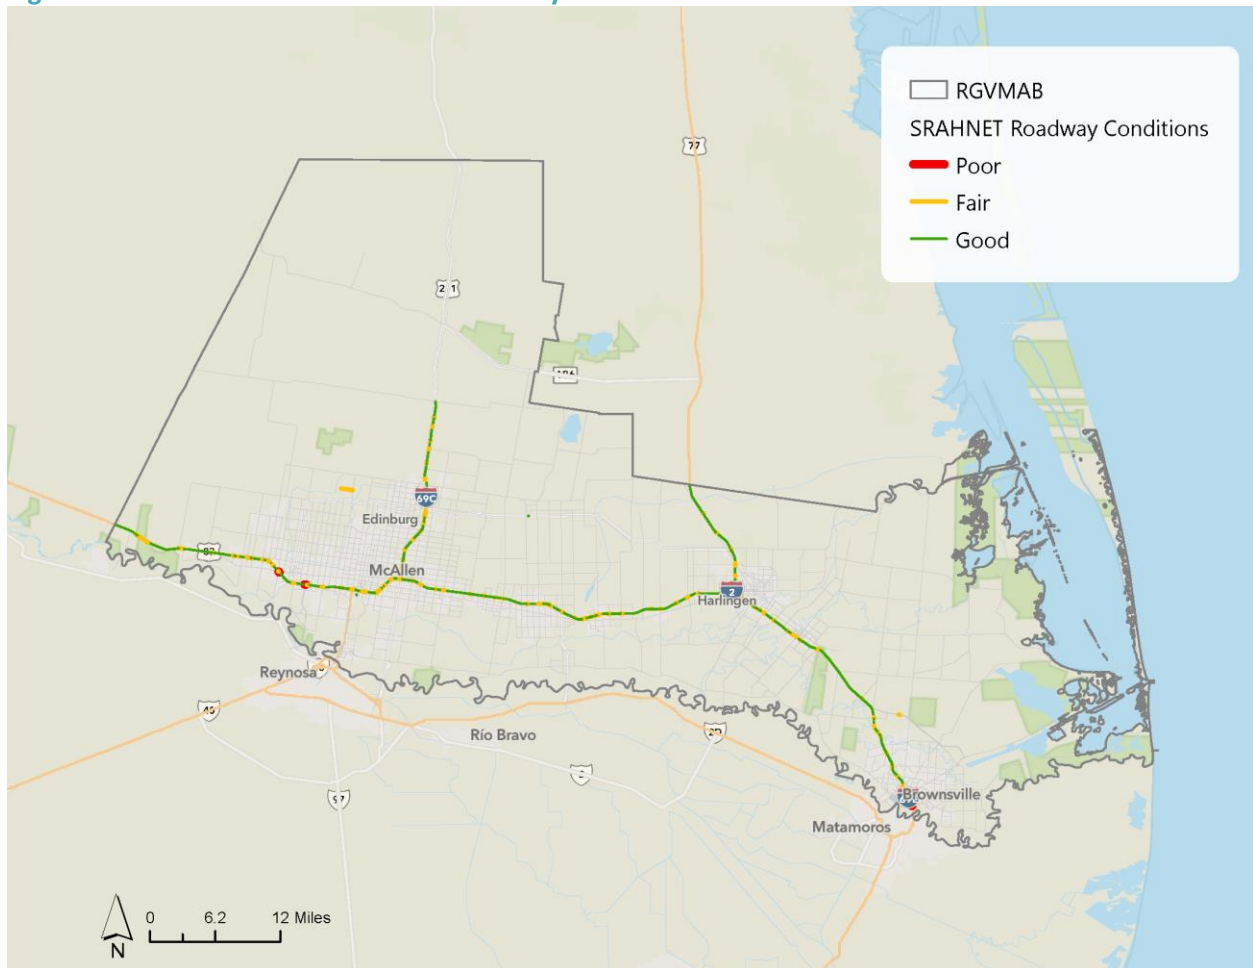
Figure 13: RGVMAB NHS-STRAHNET Roadway Conditions

As a supplement to the graphical review of the NHS pavement conditions represented in **Figure 8** through **Figure 12**, the roadway pavement conditions for the Strategic Highway Network (STRAHNET) within the RGVMAB were also reviewed separately from the NHS maps. STRAHNET pavement conditions are shown at the regional level in **Figure 13**. The majority of the STRAHNET within the RGVMAB is recorded in good or fair condition with only 6 small segments rating in poor condition. These segments are shown in **Figure 14**, **Figure 15**, and **Figure 16**.

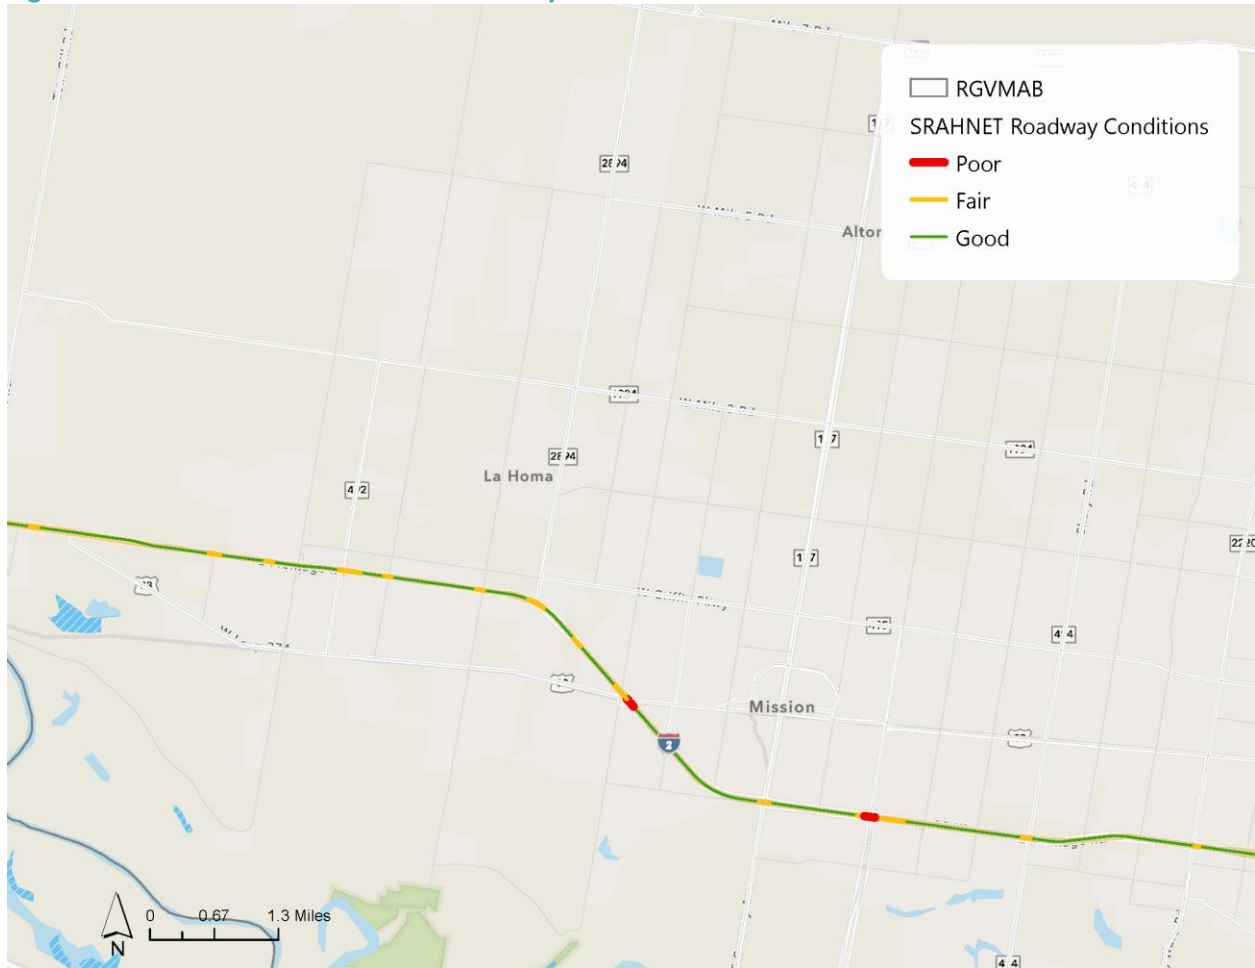
Figure 14: RGVMAB NHS STRAHNET Roadway Conditions – Mission Area

Figure 14 displays Mission area NHS STRAHNET roadway pavement conditions. Two small segments on IH 2 have a poor rating condition on the southside of the BUS 83 overpass and the west side of the FM 396 overpass.

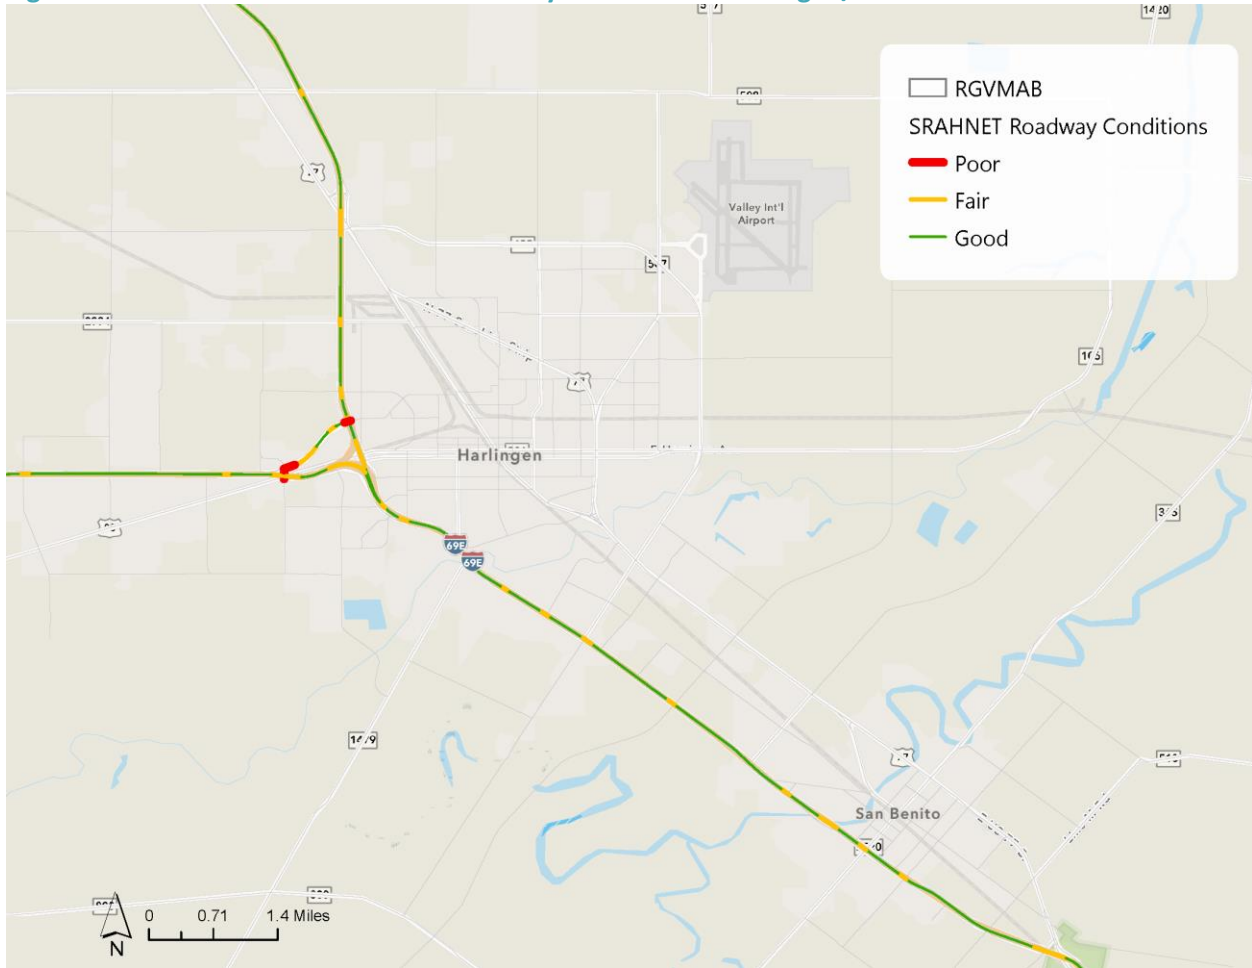
Figure 15: RGVMAB NHS STRAHNET Roadway Conditions – Harlingen/San Benito Area

Figure 15 displays Harlingen and San Benito area NHS STRAHNET roadway pavement conditions. Two small segments on Jefferson Valley Fair (US 54) have a poor condition rating crossing under IH 2 and IH 69E.

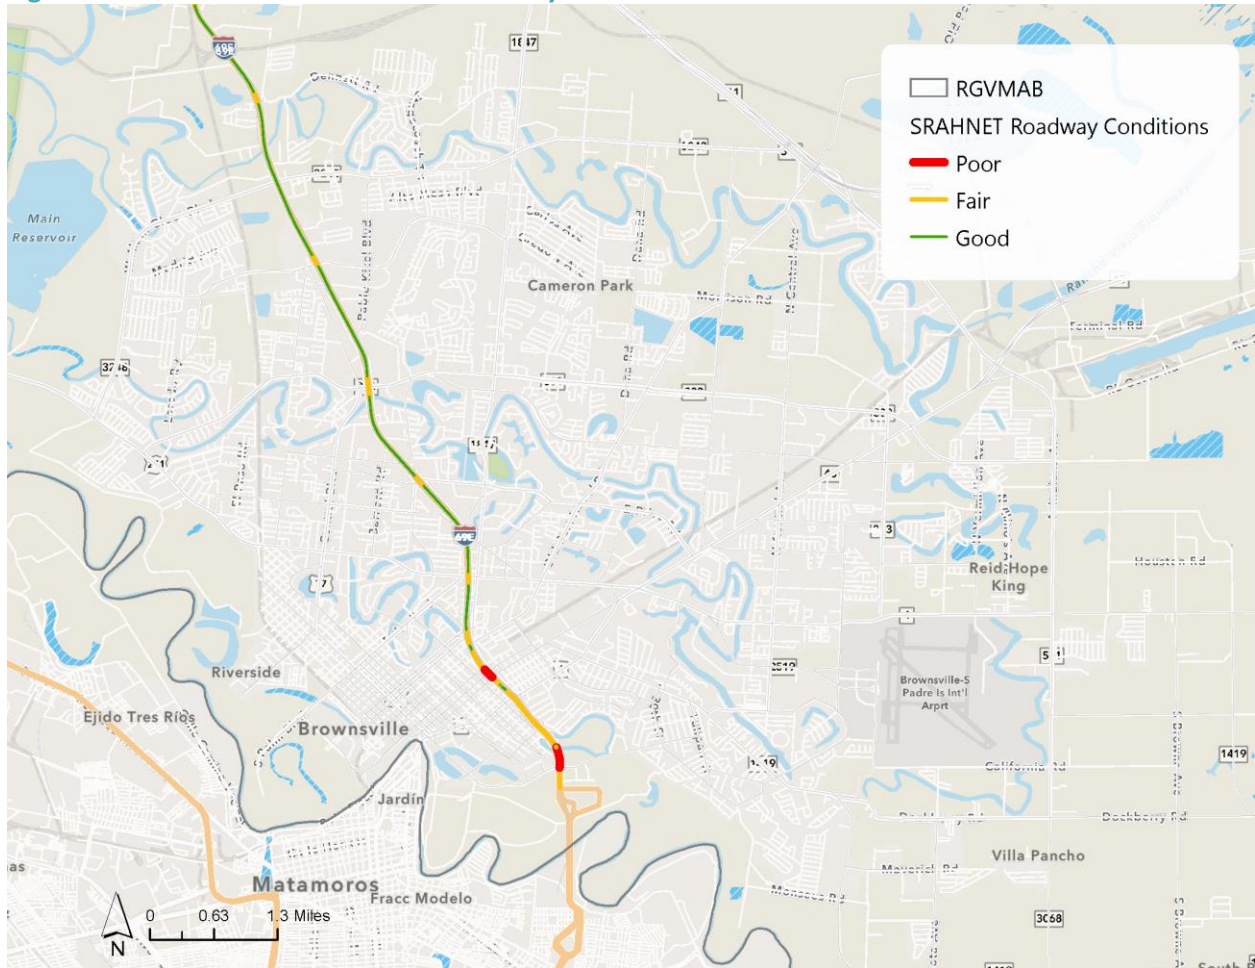
Figure 16: RGVMAB NHS STRAHNET Roadway Conditions – Brownsville Area

Figure 16 displays Brownsville area NHS STRAHNET roadway pavement conditions. Two segments are shown to have a poor condition rating on IH 69 E between 12th and 14th Streets and between East University Boulevard and just east of East 27th Street.

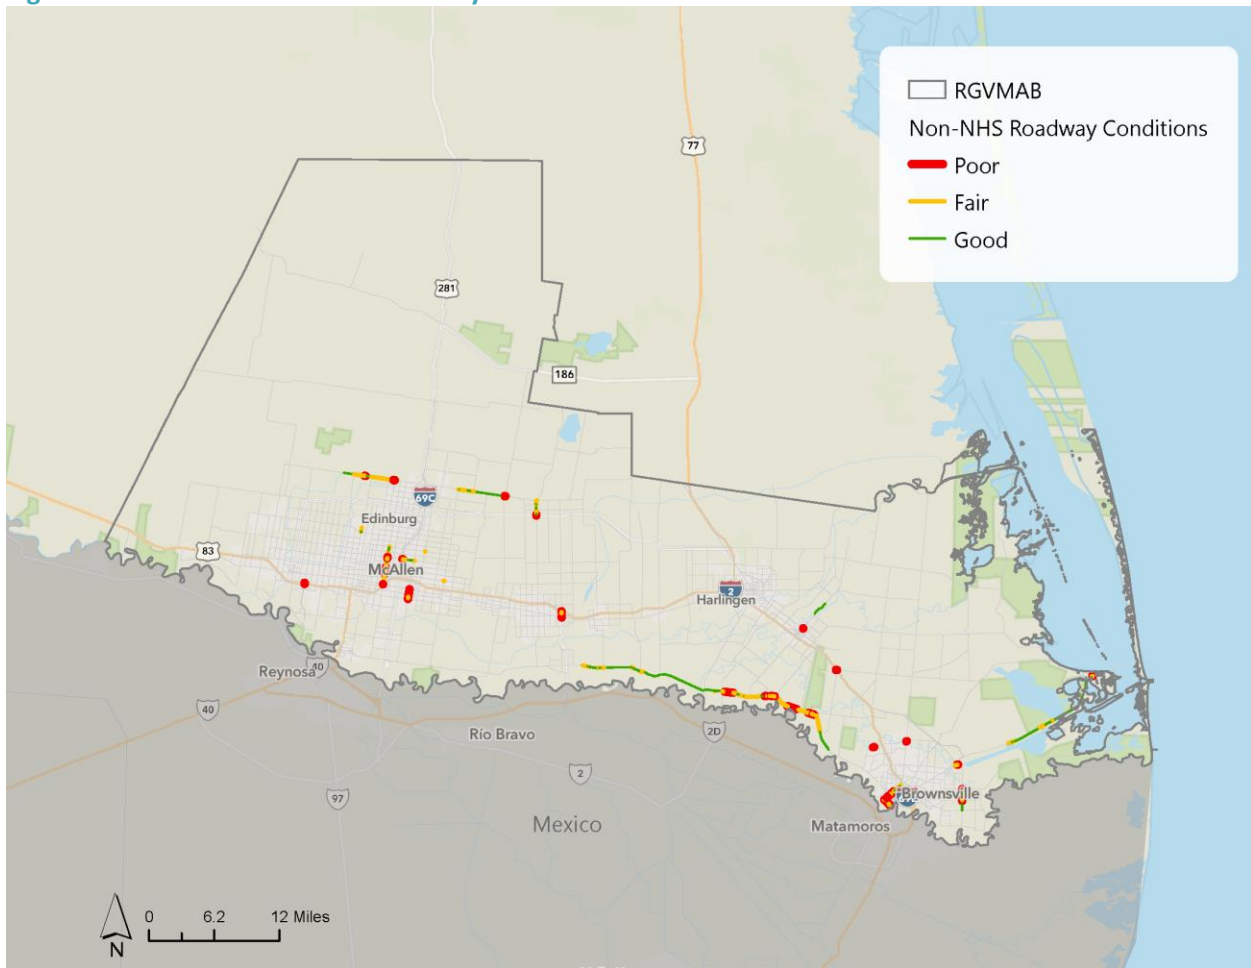
Figure 17: RGVMAB Non-NHS Roadway Conditions

Figure 17 displays roadway pavement conditions for the Non-NHS network with IRI data at the RGVMAB level, showing majority of the infrastructure to be in a state of good repair.

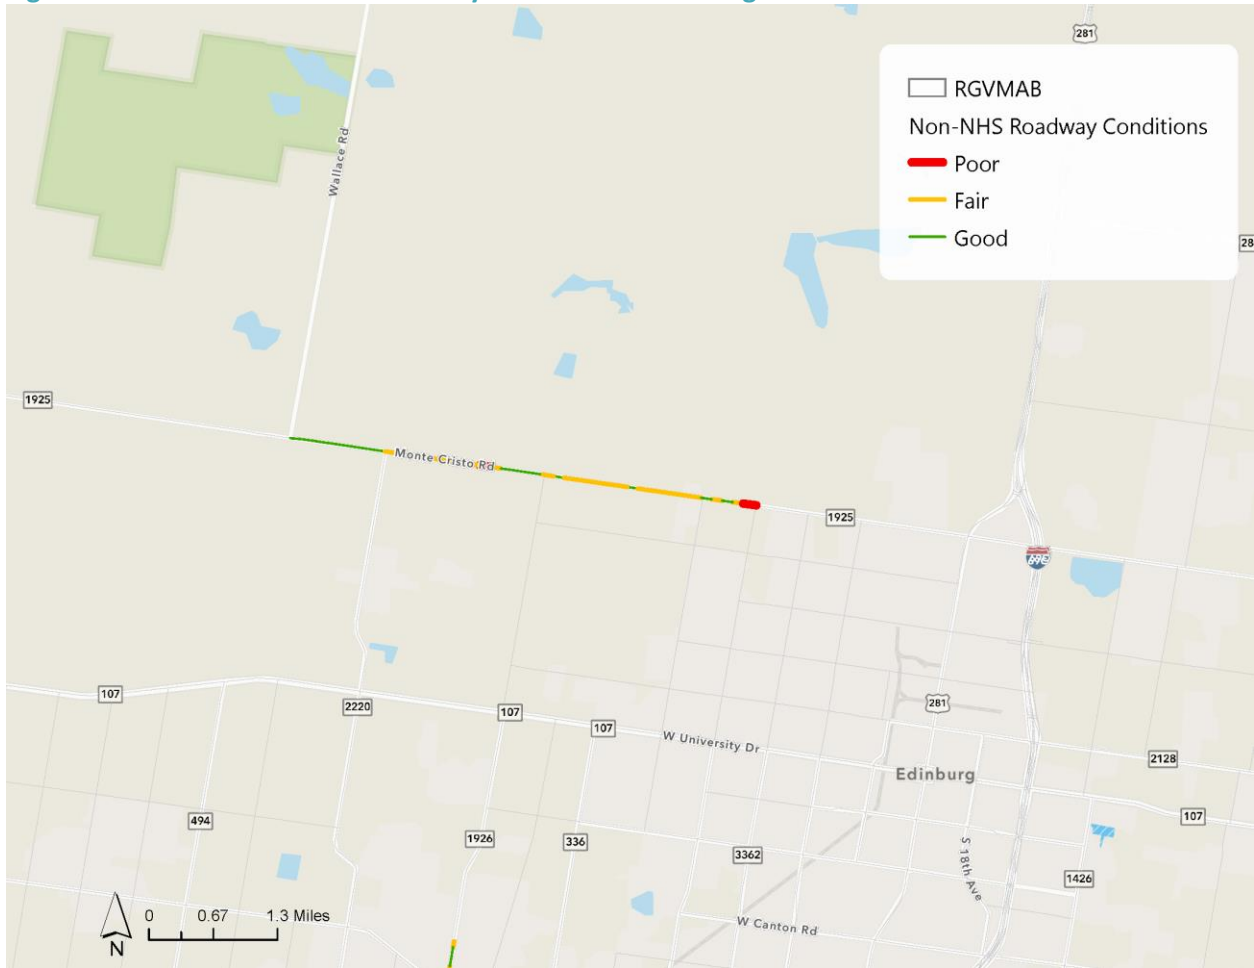
Figure 18: RGVMAB Non-NHS Roadway Conditions – Edinburg Area

Figure 18 shows one portion of FM 1925 with a poor condition rating on just west of North McColl Rd just northwest of Edinburg.

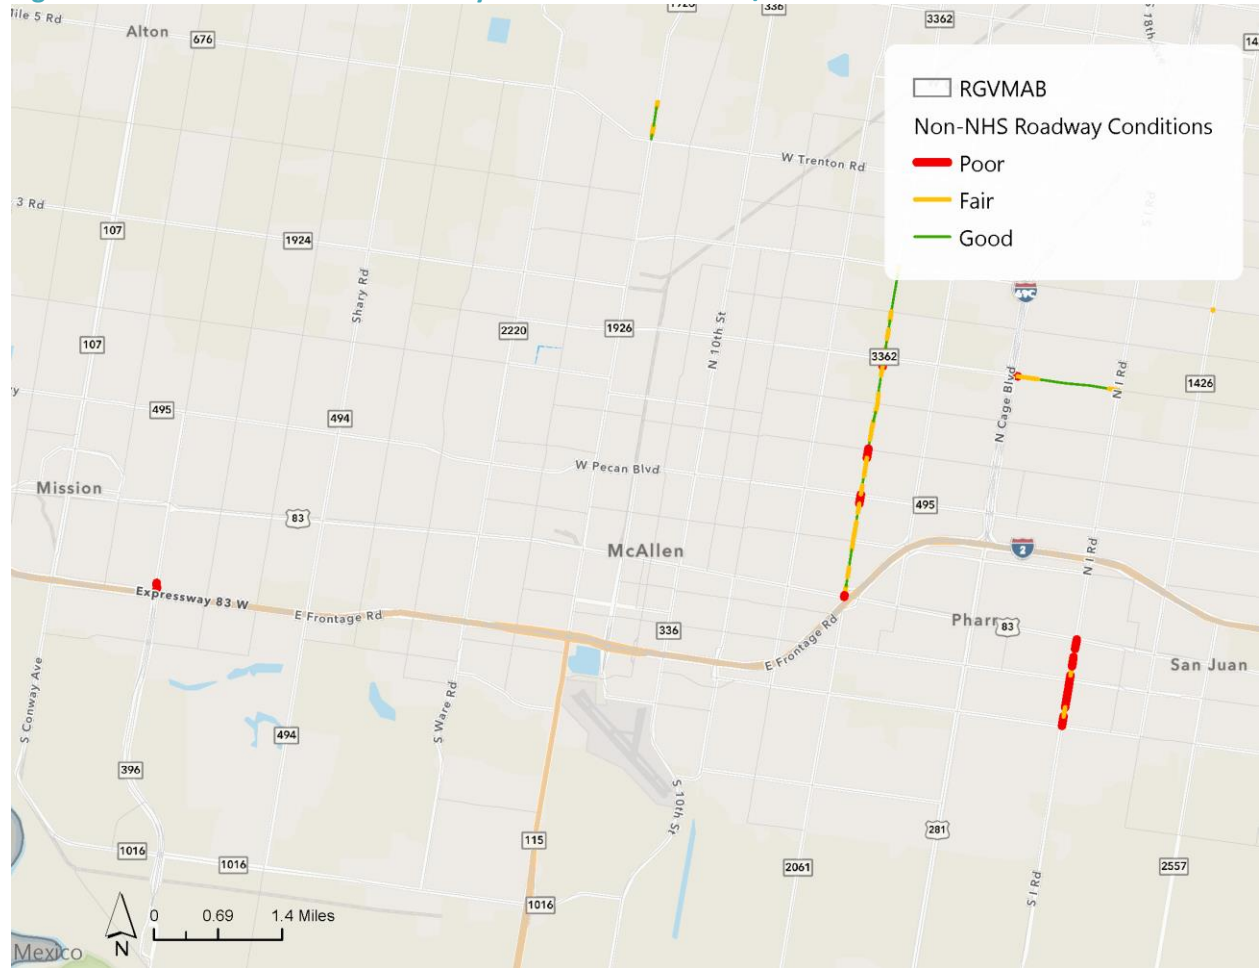
Figure 19: RGVMAB Non-NHS Roadway Conditions – McAllen/Pharr Area

Figure 19 shows a number of Non-NHS segments in the McAllen/Pharr area with a poor condition rating. Of note is a stretch on S Veterans Blvd between W Ridge Rd and E Center Ave with mostly contiguous poor rating. Other segments of note are intermittent segments on N Jackson Rd at the intersection of E Business 83, the intersection of US 495, and at the intersection of W Sioux Rd. One other segment appears along Bryan Rd just north of IH 2.

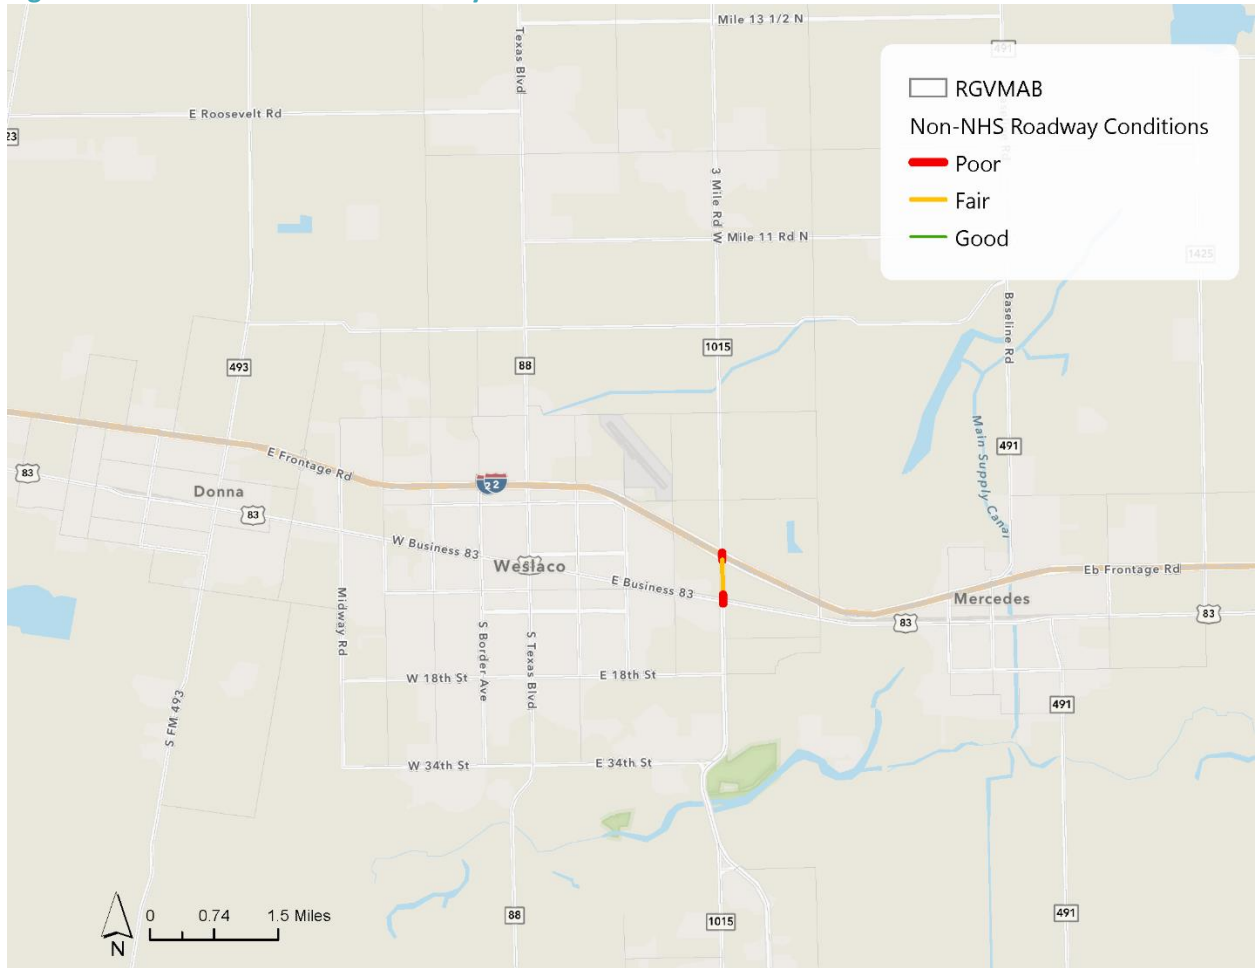
Figure 20: RGVMAB Non-NHS Roadway Conditions – Weslaco Area

Figure 20 shows two Non-NHS segments in the Weslaco Area with a poor condition rating both along S International Blvd; just north of E 18th St and at the IH 2 overpass.
