MEMORANDUM

DATE: June 26, 2020
TO: Andrew Cannon
CC: Luis Diaz
FROM: JD Allen
RE: RGVMPPO 2045 MTP – Bridge and Roadway Condition Analysis

RGVMPO Transportation System Conditions and Performance

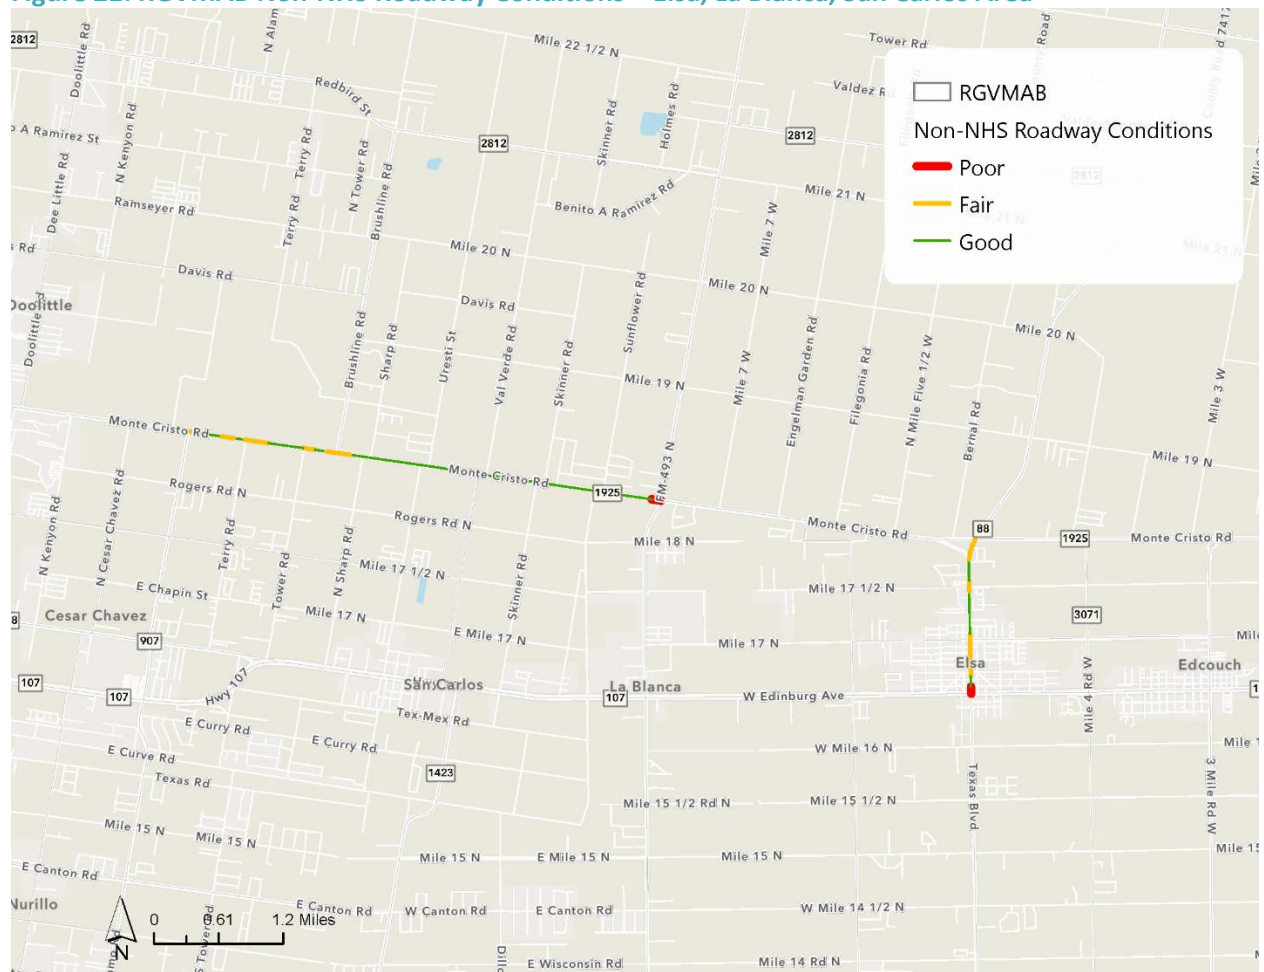
Figure 21: RGVMAB Non-NHS Roadway Conditions – Elsa, La Blanca, San Carlos Area

Figure 21 shows two brief segments of Non-NHS with poor condition rating in the Elsa, La Blanca, San Carlos Area; one along FM 1925, just west of La Blanca Rd and the other on Mile 5 Road W (Broadway St) just north of W Edinburg Ave.

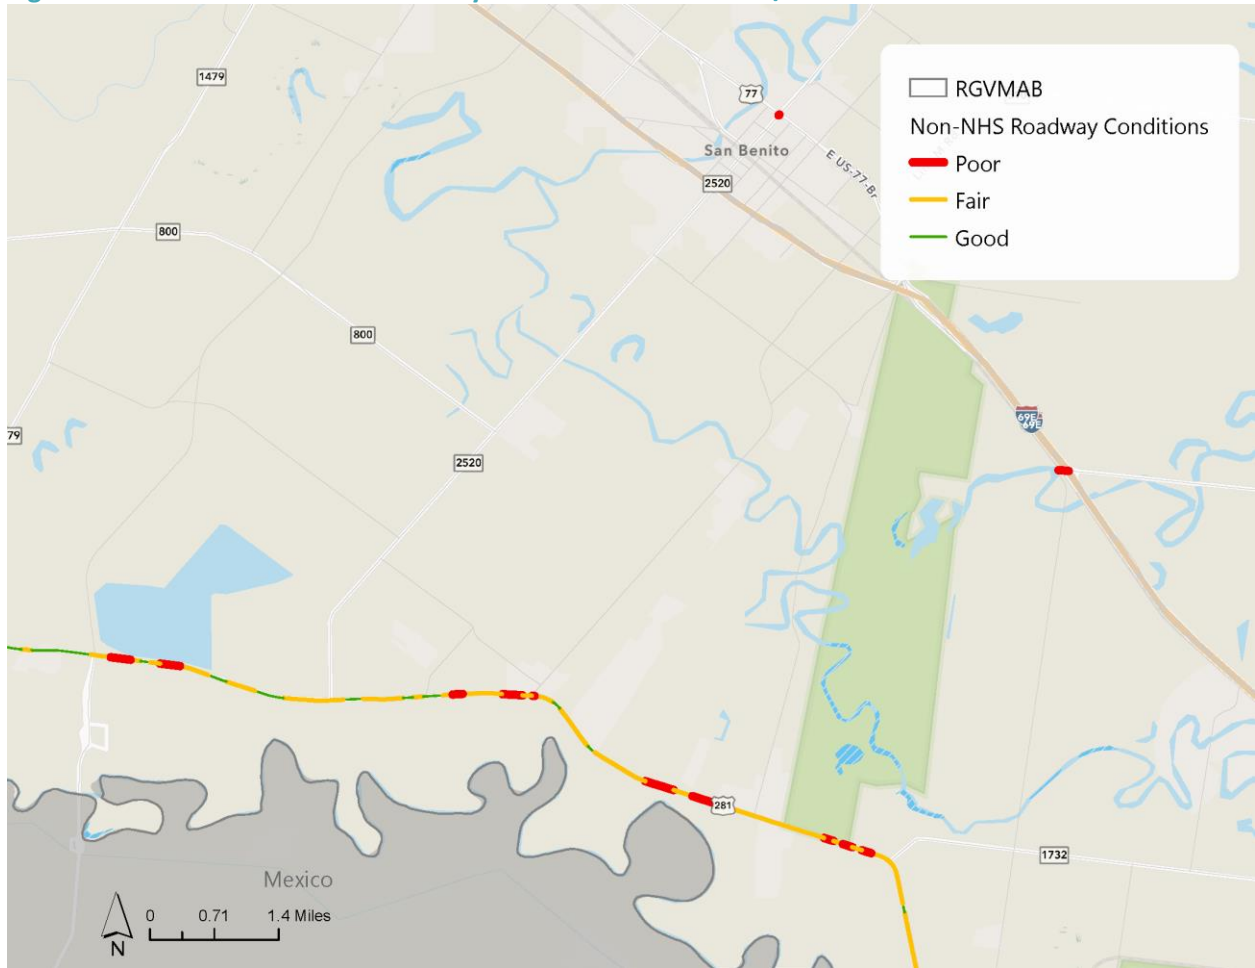
Figure 22: RGVMAB Non-NHS Roadway Conditions – La Paloma/San Benito Area

Figure 22 shows a number Non-NHS of segments with poor rating in the La Paloma/San Benito area. The majority of these segments occur along SH 281 off and on between Santos Gomez Dr and just east of FM 509. The other two segments of Non-NHS with poor IRI rating shown in Figure 22 are on Rice Track Rd passing under IH 69 East and on SH 345 just north of Business 77.

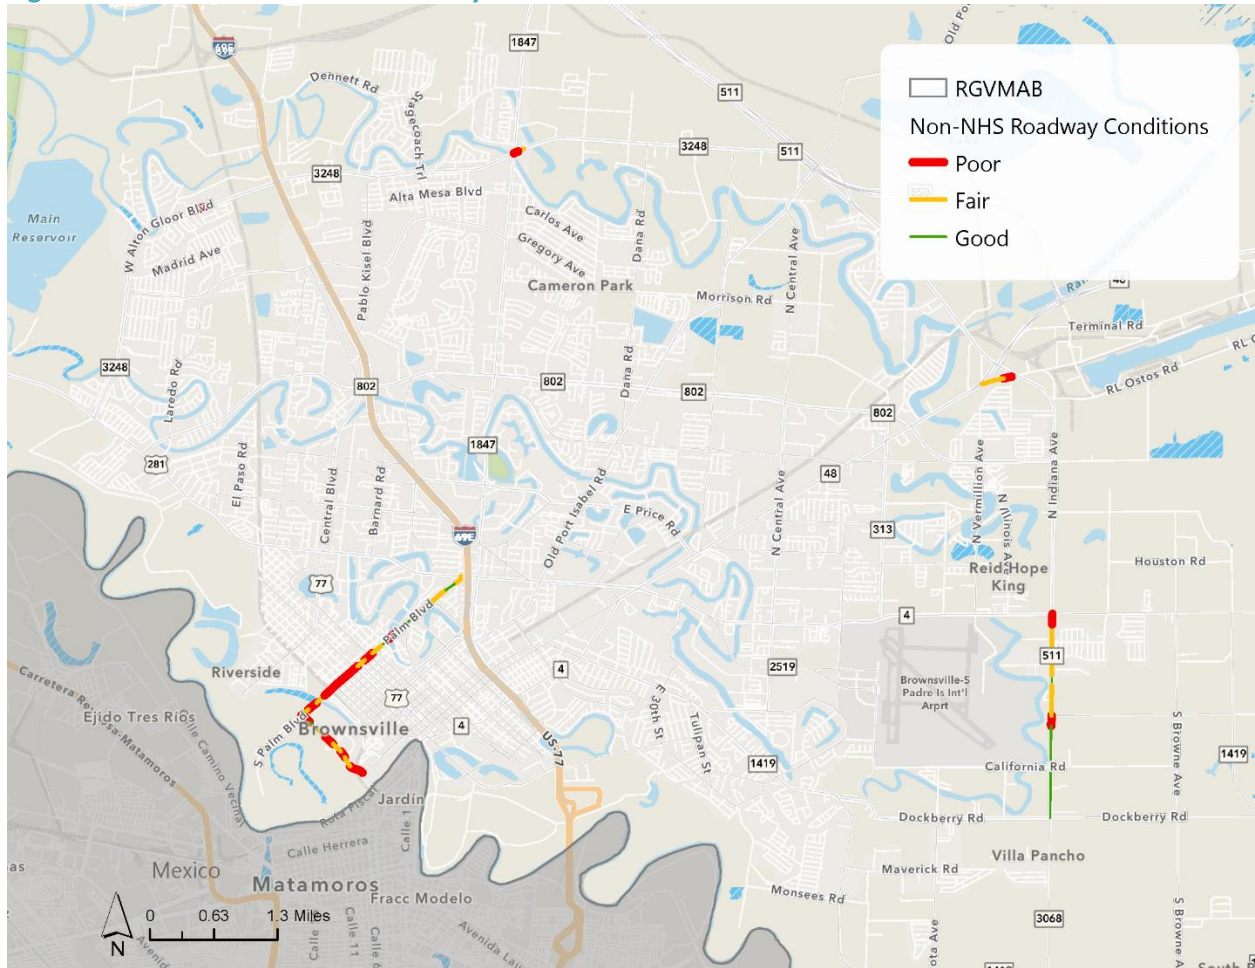
Figure 23: RGVMAB Non-NHS Roadway Conditions – Brownsville Area

Figure 23 shows Non-NHS segments with poor rating in the Brownsville area. One adjoining stretch occurs along Mexico Blvd and Palm Blvd, between Sam Perl Blvd and W Jefferson St. Two small segments occur on S Indian Ave just west of the Brownsville South Padre Island International Airport. One segment occurs on Padre Island Hwy just west/southwest of N Indian Ave. One segment occurs on Dr. Hugh Emerson Rd. just west of Paredes Line Rd.
